UNITED STATES AIR FORCE IERA

Characterization of Environmental and Health Exposures During a Composite Aircraft Fire and Simulated Aircraft Recovery Operations

July 2001

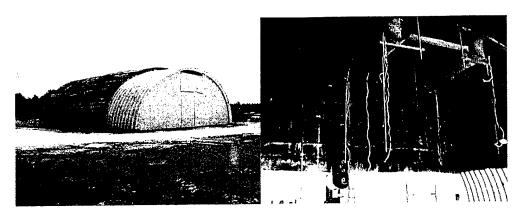
Figure 1. Burn Facility

Large-scale tests were conducted on Tyndall AFB, FL at the AFRL Test Range II Burn Facility shown in **Figure 1**. The facility is an 80 foot by 75 foot quonset hut structure with a 32 foot maximum ceiling height. Estimated volume of the hangar is 154,000 ft³.

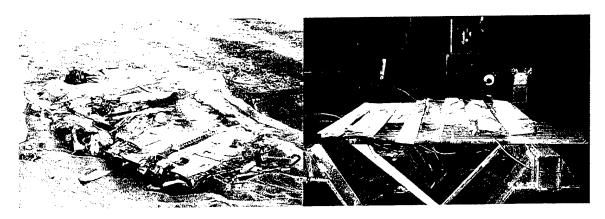
Figure 5. Damaged Composite Material

A 12.5-ton bulldozer with caterpillar tracks repeatedly ran over the wing (**Figures 5,6, and 7**). The material was laid flat on the concrete and then it was placed on top of an angle iron to increase the weight/force being applied (to attempt to further damage). There was considerable damage to the exterior of the wing and probably internal damage. The wing was hollow thus vulnerable to crushing and general breaking of the composite material. The entire wing box was weighed intact prior to cutting and introducing damage. An Ohaus electronic industrial scale was used to obtain the pre- and post- weights. Weights were obtained with the materials placed in a wooden crate. Post-burn weights were obtained by placing burned composite sections and recovered pieces back into the crate prior to re-weighing the composite. Composite material percentage was estimated based upon the weight of the wing box.

Twenty pounds of composite material was cut out of the wing box for this test (**Figure 6**). In addition to the JP-8, the composite material sample was placed above the fuel surface. The fire size for the first composite burn was a 5ft² pan (2.25 feet by 2.25 feet) with 10 gallons of JP-8 fuel. The 5 ft² pan was placed inside an eight-foot diameter pan. The composite material was placed on a grate supported by two custom-made steel horses. **Figure 8** shows the test setup. The fuel was ignited with a propane torch. **Figure 9** shows the fire one minute after ignition.

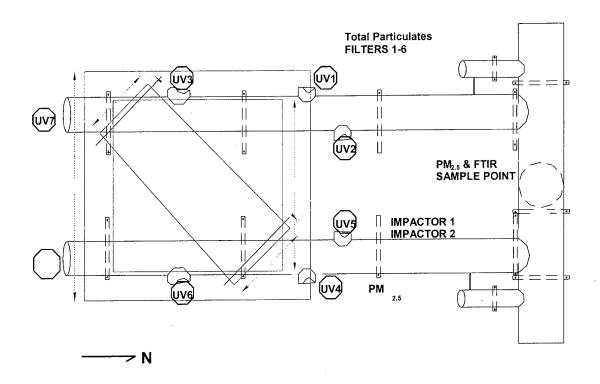
Figure 14. Location of Thermocouples, Total Particulate, Impactors, and PM _{2.5} Samplers

a) Temperature: Temperatures were measured with Type-K thermocouples positioned at various points around the fire, in the ductwork, and within the composite material. The position of the duct sensors is shown in Figure 14. Figure 15 shows the approximate position of the thermocouples near the floor and within the composite wing box. Instrumentation for tests in the burn facility included temperature measurements in the test pan, around the test pan, above the test pan and in the ceiling. The ceiling measurement locations are shown in

Figure 14. Temperatures were measured at each of the ventilation system ducts shown in Figure 14 and are identified in the test data as UV1 - UV7.

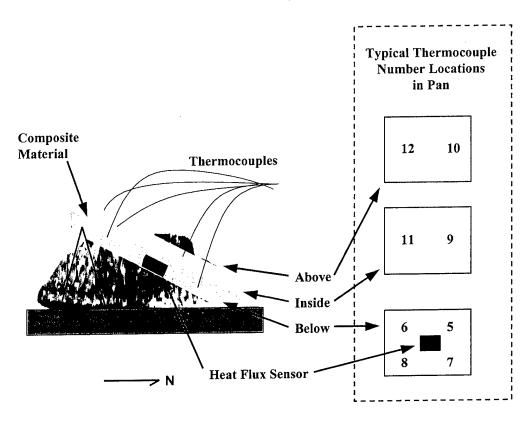
Figure 15. Approximate Thermocouple and Heat Flux Sensor Locations

b) Heat Flux: Directional Flame Thermometers (DFT) were located in the flame zone to measure hot wall heat flux or radiating temperatures. These sensors are a type of thin-skin calorimeter developed by M. H. Burgess and C. J. Fry. They are constructed by attaching a thermocouple to a metal plate of known thickness (L), specific heat (C_p) , and density (ρ) . Heat flux (q_{plate}) is calculated by measuring the temperature change of the metal plate (dT_{plate}/dt) and applying the following formula:

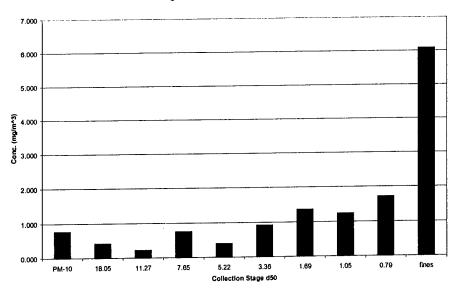
Figure 19 Particle Size Profile, 13 Sept 2000

Analysis of total particulate filter catches by TEM indicated that the primary element present in the bulk of the particulate matter was carbon. This knowledge prompted a reevaluation of the cascade impactor data, using the density of carbon as the expected particulate density. Because of the sensitivity of the particle diameter calculations to the particle density and also the further dependence of the particle number calculations on density, this new density figure produces substantially different results, which are listed in Table 14.

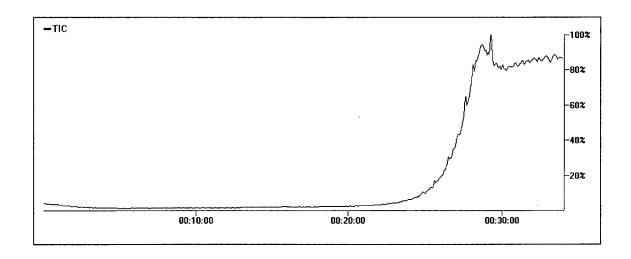
Figure 28. TIC from SPME sampler PDMS-H03, 15 Sept 2000

The TIC from the analysis of the second PDMS fiber, designated PDMS-H03, is shown in **Figure 28**. Aside from baseline variations this displays two readily discernable peaks, and these mass spectra must be isolated from the column bleed by background subtraction. The peak eluting at 29.59 min appears to be diethylphthalate. The peak eluting at 31.76 min displayed a base peak of 100 daltons and its best library match was 2 (5H)-Thiophenone. These results are also summarized in Table16.

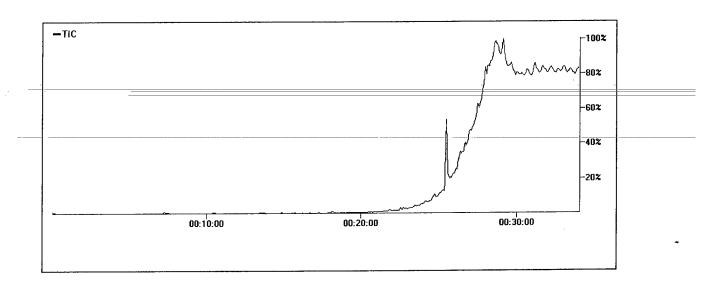
Figure 33. TIC from SPME sampler PDMS-HO2, 18 Sept 2000

A PDMS sampling fiber, PDMS-H02 was also hung on 18 September 2000. Its TIC is shown in **Figure 33**. The prominent peaks are tentatively identified as 2,4-diisocyanato-1-methylbenzene and diethylphthalate. A second PDMS sampling fiber, PDMS-H04 was also hung. Its TIC is shown in **Figure 34** and displays three significant peaks, which are tentatively identified as 2,4-diisocyanato-1-methylbenzene, the methyl ester of 4-hydroxybenzoic acid, and diethylphthalate.
